LEVEL IV  
**AMPHIBIOUS LAKE DAM**  
**NJ 00457**

**PHASE 1 INSPECTION REPORT  
NATIONAL DAM SAFETY PROGRAM**

June, 1979

AMPHIBIOUS LAKE DAM (NJ00457)

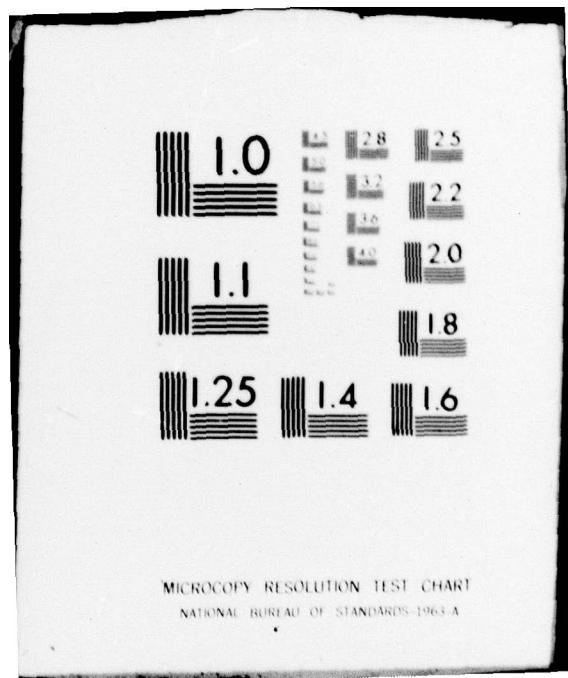
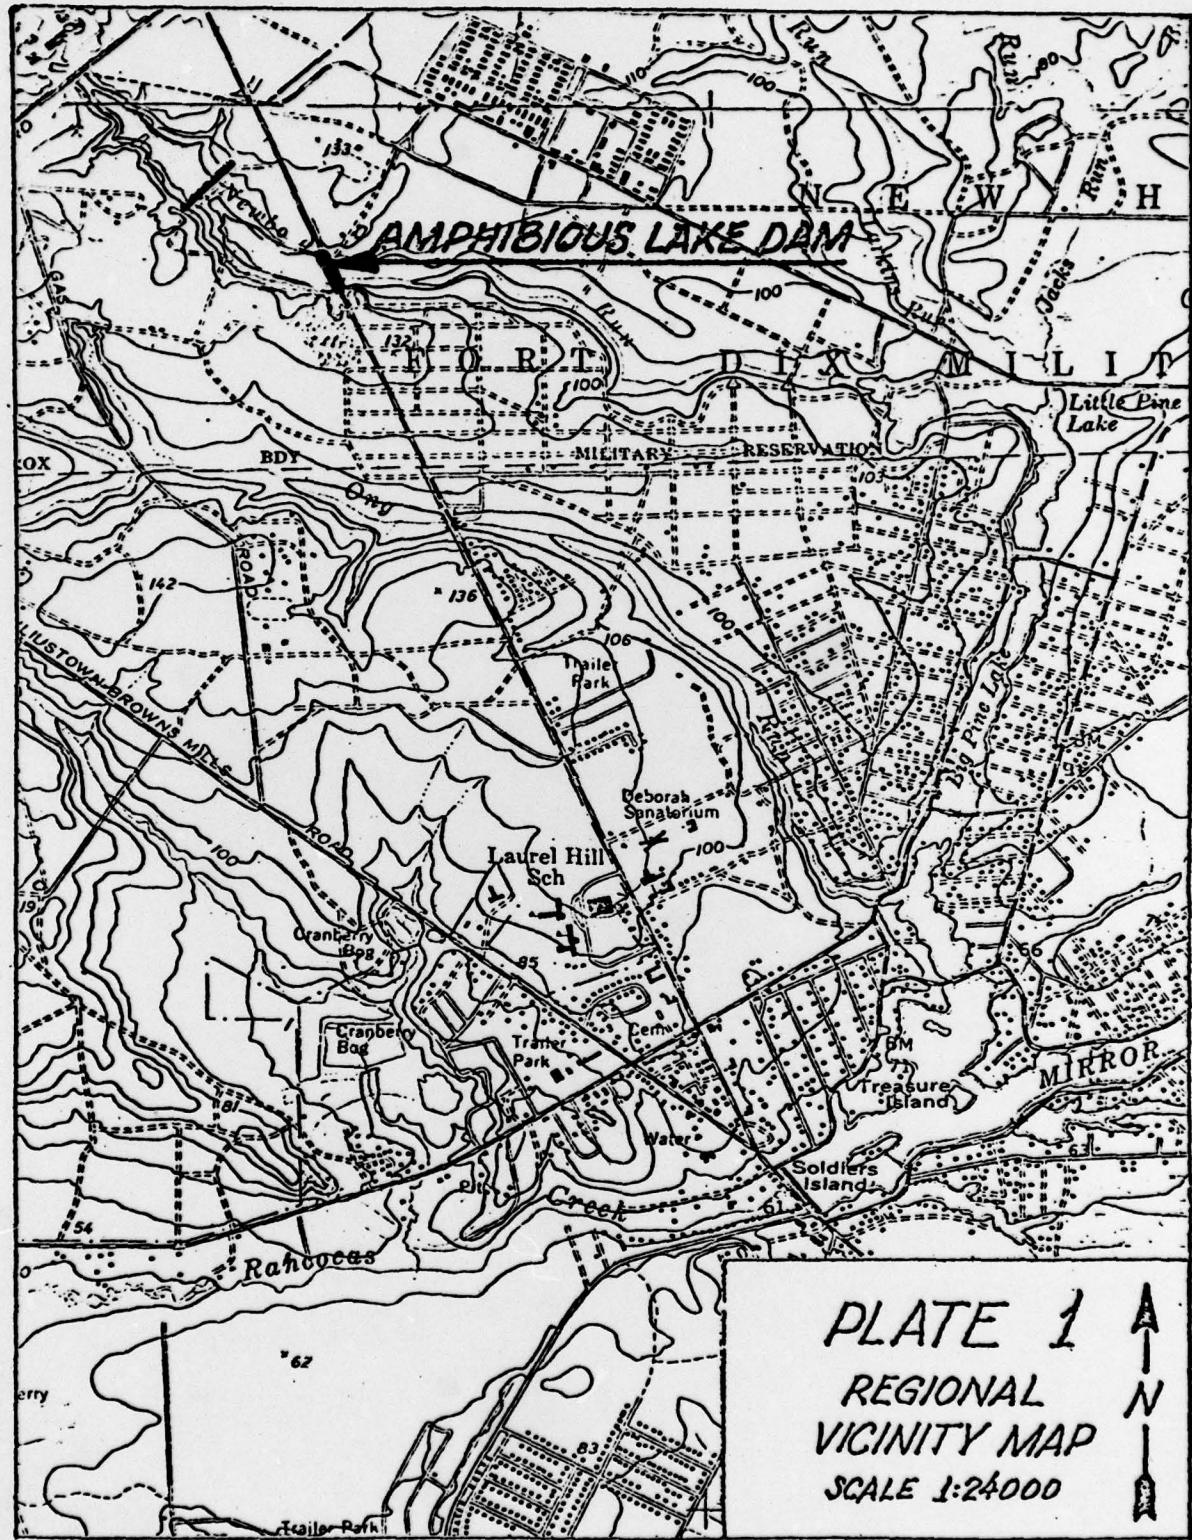
**PLATE 1**  
**REGIONAL**  
**VICINITY MAP**  
**SCALE 1:24000**

b. Location. Amphibious Lake Dam is located on Burlington County Route 545 (Texas Avenue) approximatley 3 miles south of Wrightstown, New Jersey. Route 545 is constructed on top of the embankment. The dam site is shown on the USGS Quadrangle entitled "Browns Mills, New Jersey" at coordinates N 39° 59.7', W 74° 36.1'. A regional location plan of Amphibious Lake Dam is enclosed as Plate 1, Appendix E.
